FRACTURE AND FATIGUE OF BI-MATERIALS

JAMES W. MAR

TECHNOLOGY LABORATORY FOR ADVANCED COMPOSITES  
MASSACHUSETTS INSTITUTE OF TECHNOLOGY  
CAMBRIDGE, MASSACHUSETTS 02139

FINAL REPORT FOR PERIOD OCTOBER 1979-SEPTEMBER 1980

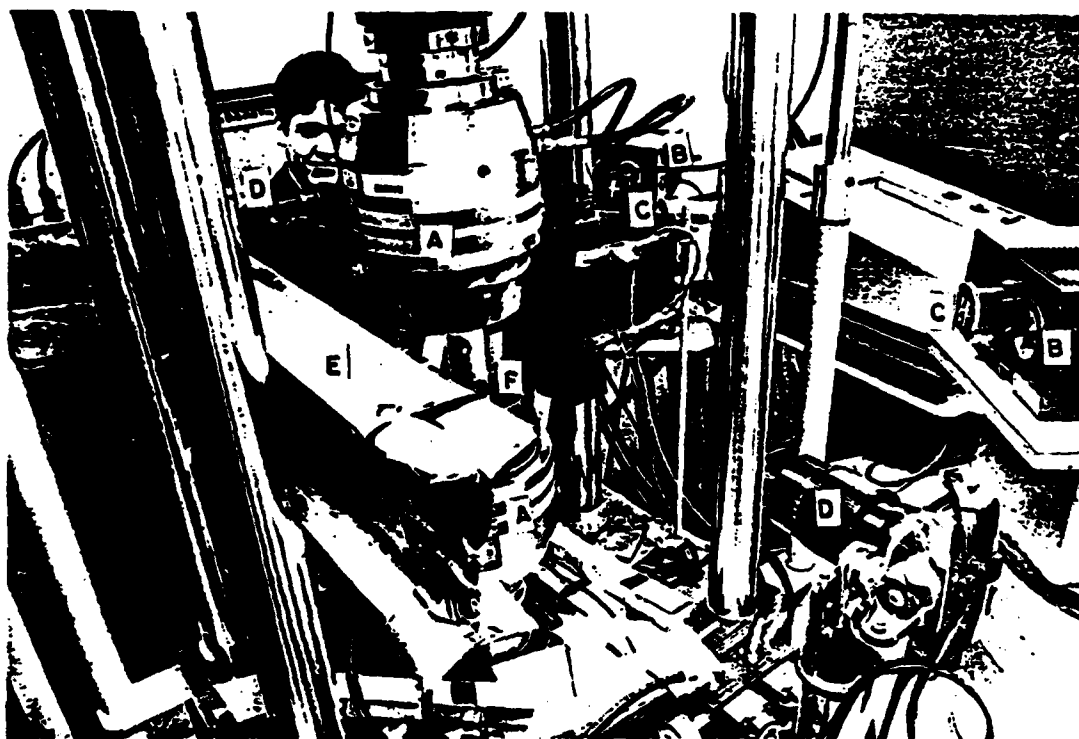
- A) HYDRAULIC GRIPS
- B) 500 WATT SLIDE PROJECTOR
- C) ZOOM LENS WITH KNIFE EDGE SLIT
- D) CAMERA
- E) VIBRATION ISOLATION MOUNTING
- F) SPECIMEN AND MOIRE GRILL

**FIGURE 5    EXPERIMENTAL SETUP**

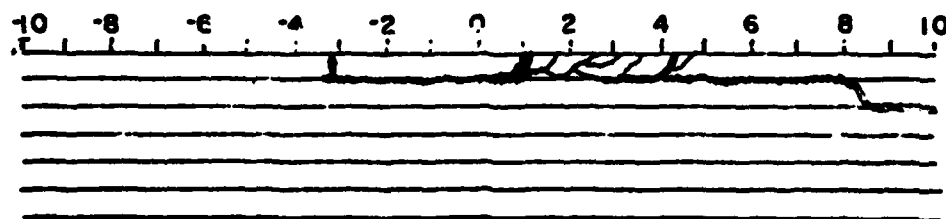
( $\pm 45/0$ )<sub>s</sub> Cross Section at 1.5

Longitudinal Cut 0.5 mm. from Right Edge of Hole

Longitudinal Cut 0.5 cm. from Right Edge of Hole

FIGURE 21 FATIGUE DAMAGE IN  
CROSS SECTIONS FROM TEST 63B
